Flood Control Project Maintenance
2015 Structure Summary Report
Overall Unit and Item Ratings

San Joaquin County Flood Control and Water Conservation District

Duck Creek Diversion Weir And Control Structure

Flood Control Project Maintenance**Unit Cover Sheet****2015 Structure Inspection Results****San Joaquin County Flood Control and Water Conservation District**

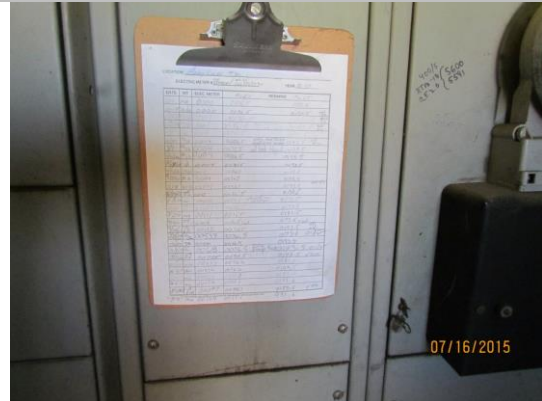
Photo 1 of 1 : ST_2015_NA0017_19_1_20150720_00012.jpg

LM Start	0.00	Rating **	A	Issue No.	1
LM End	0.00	Issue Type +	Ma	Location *	
Category	Pump Stations			GPS Latitude/Longitude	
				Start	End
Item	Operating Log			37.982317 °	37.982317 °
				-121.249433 °	-121.249433 °
DWR ID	DWR_NA0017_19_t_2012_1				
Action/Comments					
Inspector Comments: Operational log was present at the pump station.

View of the operation log inside the pumping plant.

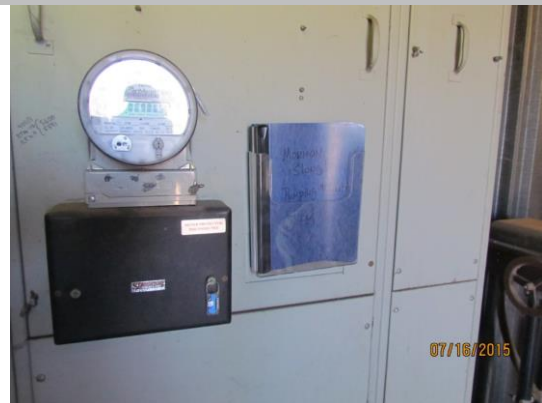
Photo 1 of 1 : ST_2015_NA0017_19_2_20150720_00013.jpg

LM Start	0.00	Rating **	A	Issue No.	2
LM End	0.00	Issue Type +	Ma	Location *	
Category	Pump Stations			GPS Latitude/Longitude	
				Start	End
Item	Operation & Maintenance Manual			37.982317 °	37.982317 °
				-121.249433 °	-121.249433 °
DWR ID	DWR_NA0017_19_t_2012_2				
Action/Comments					
Inspector Comments: O&M Manual was found inside the plant during the inspection.

View of the O&M manual inside the pumping plant.

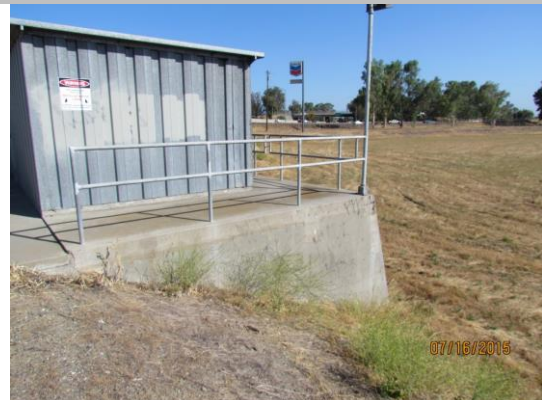
Photo 1 of 1 : ST_2015_NA0017_19_5_20150720_00015.jpg

LM Start	0.00	Rating **	A	Issue No.	5
LM End	0.00	Issue Type +	Ma	Location *	
Category	Pump Stations			GPS Latitude/Longitude	
				Start	End
Item	Safety			37.982317 °	37.982317 °
				-121.249433 °	-121.249433 °
DWR ID	DWR_NA0017_19_t_2012_5				
Action/Comments					
Inspector Comments: No safety hazard was found around the structure. All hand rails were in working condition.

View of the hand rails around the pumping plant.

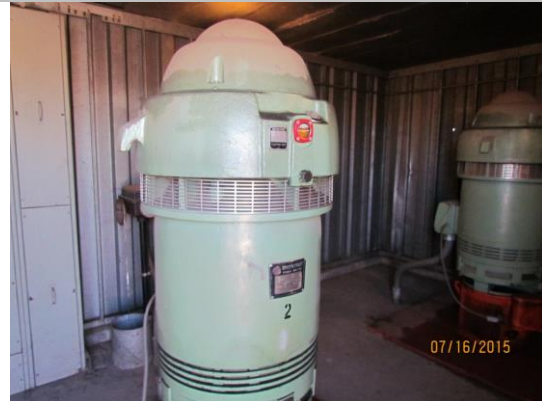
Photo 1 of 3 : ST_2015_NA0017_19_7_20150720_00016.jpg

LM Start	0.00	Rating **	A	Issue No.	7
LM End	0.00	Issue Type +	Ma	Location *	
Category	Pump Stations			GPS Latitude/Longitude	
				Start	End
Item	Pumps			37.982317 °	37.982317 °
				-121.249433 °	-121.249433 °
DWR ID	DWR_NA0017_19_t_2012_7				
Action/Comments					
Inspector Comments: The pumps appeared to be well maintained and lubricated properly and the pumping system was tested periodically.

View of the pumps inside the plant.

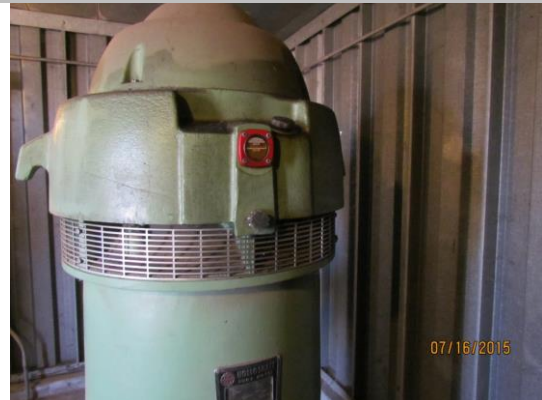
Photo 2 of 3 : ST_2015_NA0017_19_7_20150720_00017.jpg

View of the lubrication indicator on one of the pumps inside the plant.

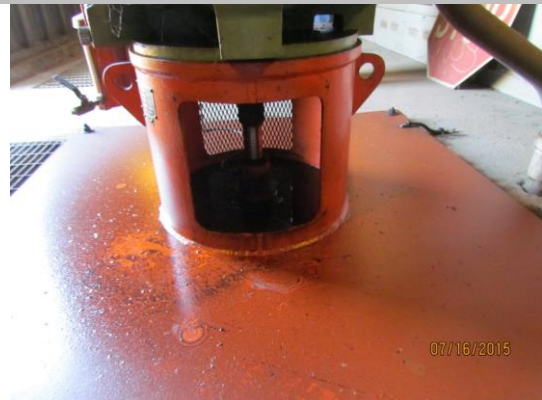
Photo 3 of 3 : ST_2015_NA0017_19_7_20150720_00018.jpg

View of below a pump inside the plant.

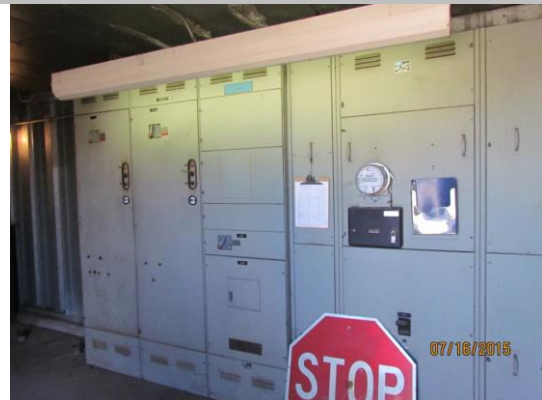
Photo 1 of 1 : ST_2015_NA0017_19_11_20150720_00019.jpg

LM Start	0.00	Rating **	A	Issue No.	11
LM End	0.00	Issue Type +	Ma	Location *	
Category	Pump Stations			GPS Latitude/Longitude	
				Start	End
Item	Pump Control Systems			37.982317 °	37.982317 °
				-121.249433 °	-121.249433 °
DWR ID	DWR_NA0017_19_t_2012_11				
Action/Comments					
Inspector Comments: The pump control system was maintained to be free of corrosion or any damage.

View of the power control system.

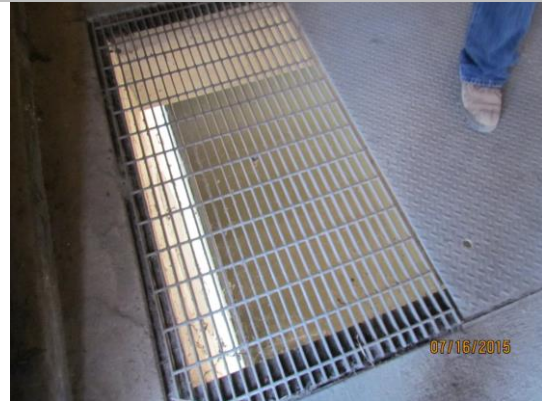
Photo 1 of 1 : ST_2015_NA0017_19_12_20150720_00020.jpg

LM Start	0.00	Rating **	A	Issue No.	12
LM End	0.00	Issue Type +	Ma	Location *	
Category	Pump Stations			GPS Latitude/Longitude	
				Start	End
Item	Sumps/Wet Well			37.982317 °	37.982317 °
				-121.249433 °	-121.249433 °
DWR ID	DWR_NA0017_19_t_2012_12				
Action/Comments					
Inspector Comments: The wet well appeared to be clear of excessive debris or sediments.

View of the wet well.

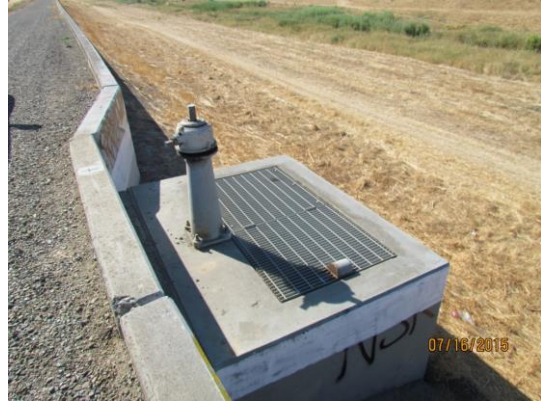
Photo 1 of 1 : ST_2015_NA0017_19_15_20150720_00022.jpg

LM Start	0.00	Rating **	A	Issue No.	15
LM End	0.00	Issue Type +	Ma	Location *	
Category	Pump Stations			GPS Latitude/Longitude	
				Start	End
Item	Sluice / Slide Gates			37.982317 °	37.982317 °
				-121.249433 °	-121.249433 °
DWR ID	DWR_NA0017_19_t_2012_15				
Action/Comments					
Inspector Comments: The slide gate appeared to be operational.

View of the slide gate.

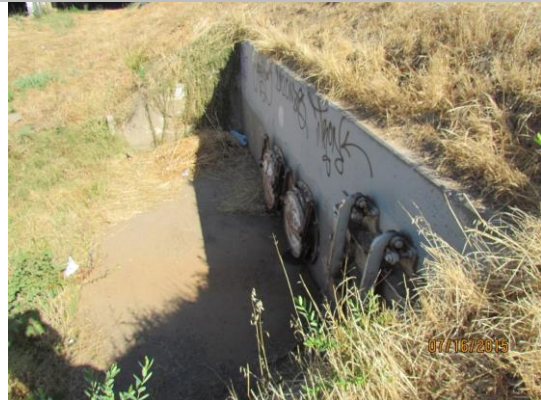
Photo 1 of 1 : ST_2015_NA0017_19_19_20150720_00023.jpg

LM Start	0.00	Rating **	A	Issue No.	19
LM End	0.00	Issue Type +	Ma	Location *	
Category	Pump Stations			GPS Latitude/Longitude	
				Start	End
Item	Flap Gates			37.982317 °	37.982317 °
				-121.249433 °	-121.249433 °
DWR ID	DWR_NA0017_19_t_2012_19				
Action/Comments					
Inspector Comments: Flap gates were in good condition and showed no damage.

View of the flap gates.

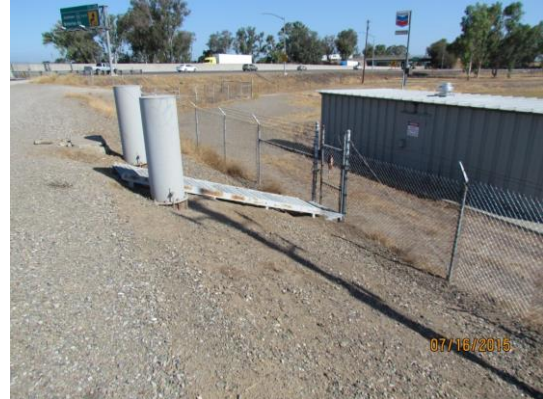
Photo 1 of 1 : ST_2015_NA0017_19_21_20150720_00024.jpg

LM Start	0.00	Rating **	A	Issue No.	21
LM End	0.00	Issue Type +	Ma	Location *	
Category	Pump Stations			GPS Latitude/Longitude	
				Start	End
Item	Security Fencing			37.982317 °	37.982317 °
				-121.249433 °	-121.249433 °
DWR ID	DWR_NA0017_19_t_2012_21				
Action/Comments					
Inspector Comments: Security fencing was in good condition without any damage.

View of the security fencing.

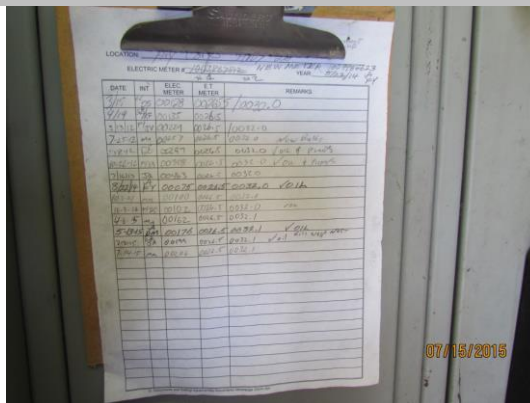
Photo 1 of 1 : ST_2015_NA0017_20_1_20150724_00014.jpg

LM Start	0.00	Rating **	A	Issue No.	1
LM End	0.00	Issue Type +	Ma	Location *	
Category	Pump Stations			GPS Latitude/Longitude	
				Start	End
Item	Operating Log			37.973983 °	37.973983 °
				-121.229967 °	-121.229967 °
DWR ID	DWR_NA0017_20_t_2012_1				
Action/Comments					
Inspector Comments: Maintenance log was present at the pumping plant.

View of the operating log inside the plant.

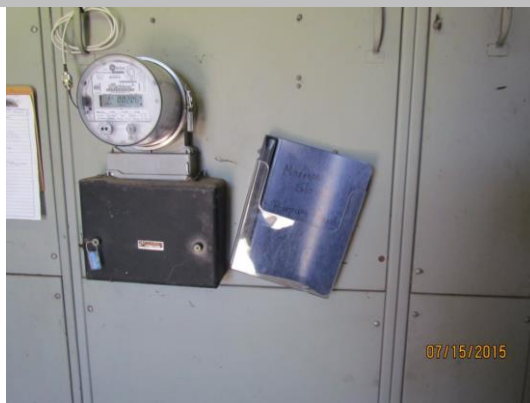
Photo 1 of 1 : ST_2015_NA0017_20_2_20150724_00015.jpg

LM Start	0.00	Rating **	A	Issue No.	2
LM End	0.00	Issue Type +	Ma	Location *	
Category	Pump Stations			GPS Latitude/Longitude	
				Start	End
Item	Operation & Maintenance Manual			37.973983 °	37.973983 °
				-121.229967 °	-121.229967 °
DWR ID	DWR_NA0017_20_t_2012_2				
Action/Comments					
Inspector Comments: The O&M Manual was present at the pumping plant next to the operating log.

View of the O&M manual inside the pumping plant.

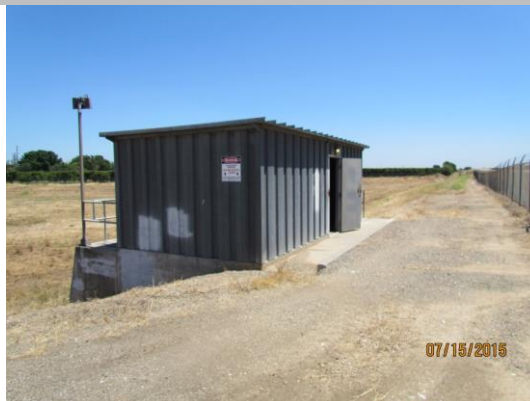
Photo 1 of 1 : ST_2015_NA0017_20_3_20150724_00016.jpg

LM Start	0.00	Rating **	A	Issue No.	3
LM End	0.00	Issue Type +	Ma	Location *	
Category	Pump Stations			GPS Latitude/Longitude	
				Start	End
Item	Plant Building			37.973983 °	37.973983 °
				-121.229967 °	-121.229967 °
DWR ID	DWR_NA0017_20_t_2012_3				
Action/Comments					
Inspector Comments: The plant building appeared to be in good structural condition.

View of the pumping plant.

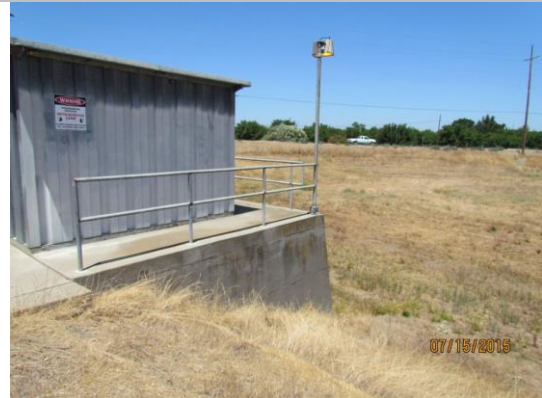
Photo 1 of 1 : ST_2015_NA0017_20_5_20150724_00017.jpg

LM Start	0.00	Rating **	A	Issue No.	5
LM End	0.00	Issue Type +	Ma	Location *	
Category	Pump Stations			GPS Latitude/Longitude	
				Start	End
Item	Safety			37.973983 °	37.973983 °
				-121.229967 °	-121.229967 °
DWR ID	DWR_NA0017_20_t_2012_5				
Action/Comments					
Inspector Comments: No safety hazard was found around the pumping plant and guard rails around the plant were in a good condition.

View of the guard rails around the pumping plant.

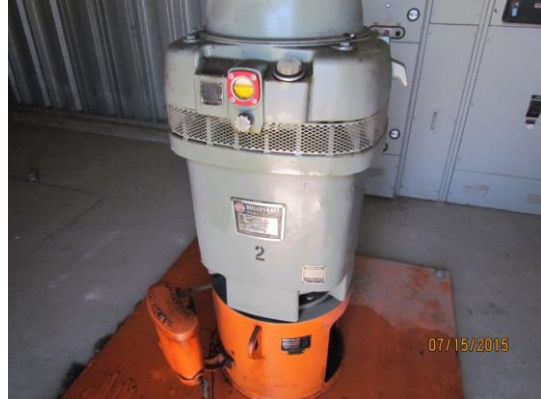
Photo 1 of 3 : ST_2015_NA0017_20_7_20150724_00018.jpg

LM Start	0.00	Rating **	A	Issue No.	7
LM End	0.00	Issue Type +	Ma	Location *	
Category	Pump Stations	GPS Latitude/Longitude			
		Start	End		
Item	Pumps	37.973983 °	37.973983 °		
		-121.229967 °	-121.229967 °		
DWR ID	DWR_NA0017_20_t_2012_7				
Action/Comments					
Inspector Comments: All pumps appeared to be in good condition and maintained properly.

View of one of the two pumps inside the pumping plant.

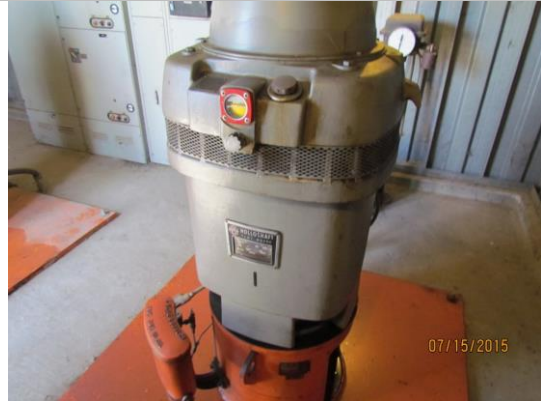
Photo 2 of 3 : ST_2015_NA0017_20_7_20150724_00019.jpg

View of another pump inside the pumping plant.

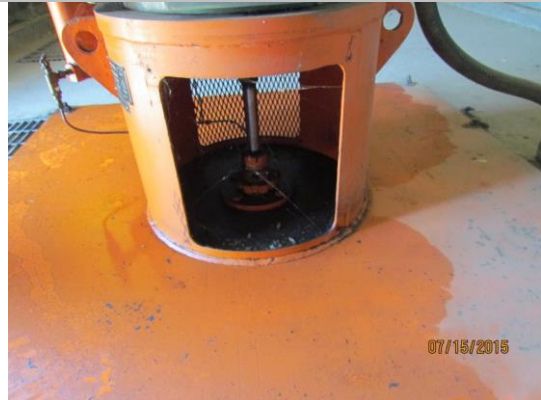
Photo 3 of 3 : ST_2015_NA0017_20_7_20150724_00020.jpg

View of bottom of a pump inside the plant.

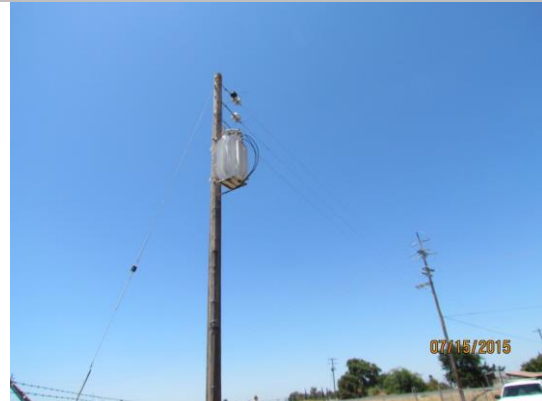
Photo 1 of 1 : ST_2015_NA0017_20_8_20150724_00021.jpg

LM Start	0.00	Rating **	A	Issue No.	8
LM End	0.00	Issue Type +	Ma	Location *	
Category	Pump Stations			GPS Latitude/Longitude	
				Start	End
Item	Power			37.973983 °	37.973983 °
				-121.229967 °	-121.229967 °
DWR ID	DWR_NA0017_20_t_2012_8				
Action/Comments					
Inspector Comments: The power source appeared to be safe and reliable.

View of the power source for the pumping plant.

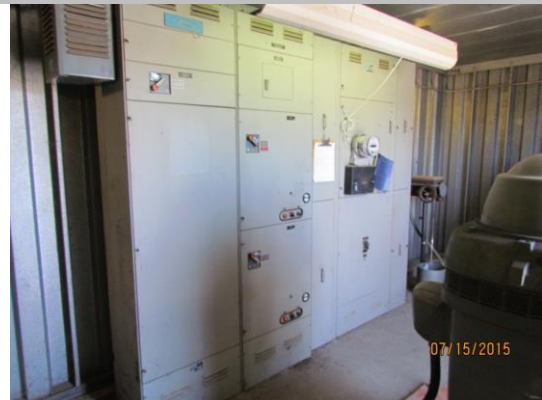
Photo 1 of 1 : ST_2015_NA0017_20_11_20150724_00022.jpg

LM Start	0.00	Rating **	A	Issue No.	11
LM End	0.00	Issue Type +	Ma	Location *	
Category	Pump Stations			GPS Latitude/Longitude	
				Start	End
Item	Pump Control Systems			37.973983 °	37.973983 °
				-121.229967 °	-121.229967 °
DWR ID	DWR_NA0017_20_t_2012_11				
Action/Comments					
Inspector Comments: The pump control system appeared to be operational and free of damage.

View of the power control systems inside the plant.

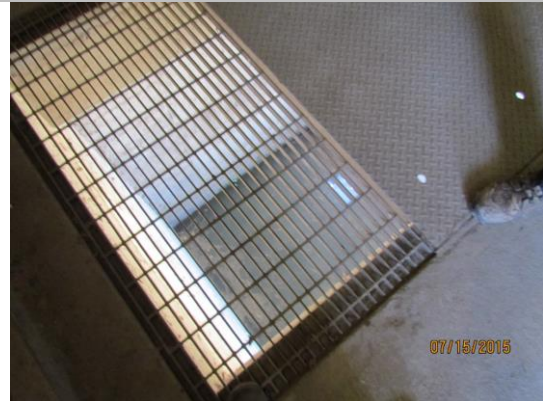
Photo 1 of 1 : ST_2015_NA0017_20_12_20150724_00023.jpg

LM Start	0.00	Rating **	A	Issue No.	12
LM End	0.00	Issue Type +	Ma	Location *	
Category	Pump Stations			GPS Latitude/Longitude	
				Start	End
Item	Sumps/Wet Well			37.973983 °	37.973983 °
				-121.229967 °	-121.229967 °
DWR ID	DWR_NA0017_20_t_2012_12				
Action/Comments					
Inspector Comments: Wet well was clear of any excessive debris.

View of wet well.

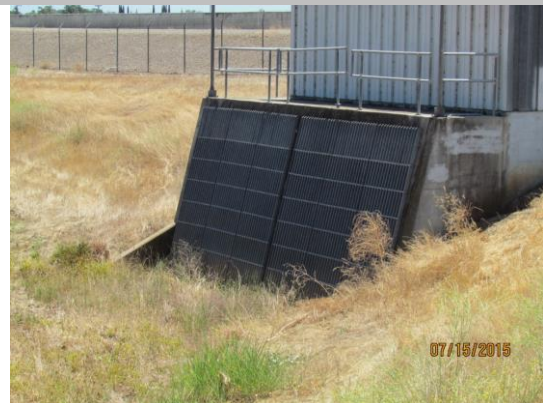
Photo 1 of 1 : ST_2015_NA0017_20_13_20150724_00024.jpg

LM Start	0.00	Rating **	A	Issue No.	13
LM End	0.00	Issue Type +	Ma	Location *	
Category	Pump Stations			GPS Latitude/Longitude	
				Start	End
Item	Trash Racks			37.973983 °	37.973983 °
				-121.229967 °	-121.229967 °
DWR ID	DWR_NA0017_20_t_2012_13				
Action/Comments					
Inspector Comments: The trash racks were free of any debris.

View of the trash racks.

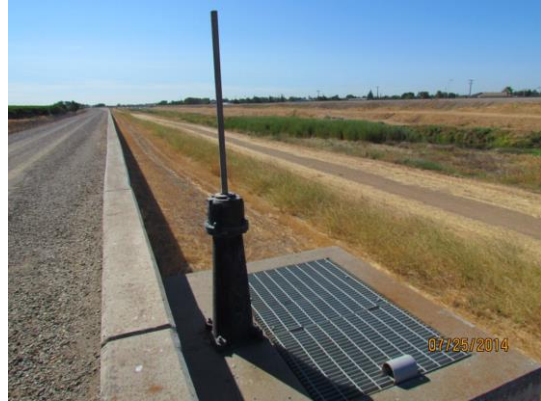
Photo 1 of 1 : ST_2015_NA0017_20_15_20150710_00011.jpg

LM Start	0.00	Rating **	A	Issue No.	15
LM End	0.00	Issue Type +	Ma	Location *	
Category	Pump Stations			GPS Latitude/Longitude	
				Start	End
Item	Sluice / Slide Gates			37.973983 °	37.973983 °
				-121.229967 °	-121.229967 °
DWR ID	DWR_NA0017_20_t_2012_15				
Action/Comments					
Inspector Comments: Slide gates appeared to be free of sediment and obstructions.

View of the slide gate.

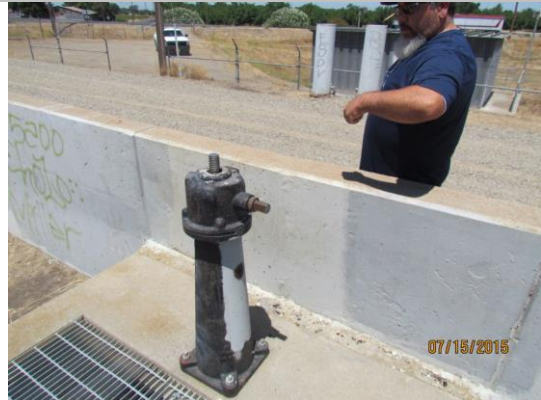
Photo 1 of 1 : ST_2015_NA0017_20_17_20150724_00025.jpg

LM Start	0.00	Rating **	A	Issue No.	17
LM End	0.00	Issue Type +	Ma	Location *	
Category	Pump Stations			GPS Latitude/Longitude	
				Start	End
Item	Manual Gate Operators			37.973983 °	37.973983 °
				-121.229967 °	-121.229967 °
DWR ID	DWR_NA0017_20_t_2012_17				
Action/Comments					
Inspector Comments: Manual gate appeared to be in good working condition.

View of the manual gate.

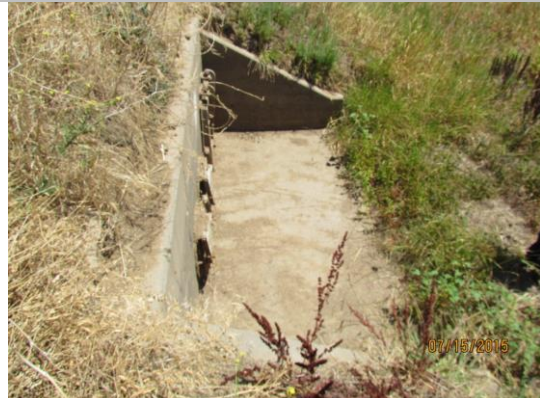
Photo 1 of 1 : ST_2015_NA0017_20_19_20150724_00026.jpg

LM Start	0.00	Rating **	A	Issue No.	19
LM End	0.00	Issue Type +	Ma	Location *	
Category	Pump Stations			GPS Latitude/Longitude	
				Start	End
Item	Flap Gates			37.973983 °	37.973983 °
				-121.229967 °	-121.229967 °
DWR ID	DWR_NA0017_20_t_2012_19				
Action/Comments					
Inspector Comments: Flap gates appeared to be in good condition.

View of the flap gates.

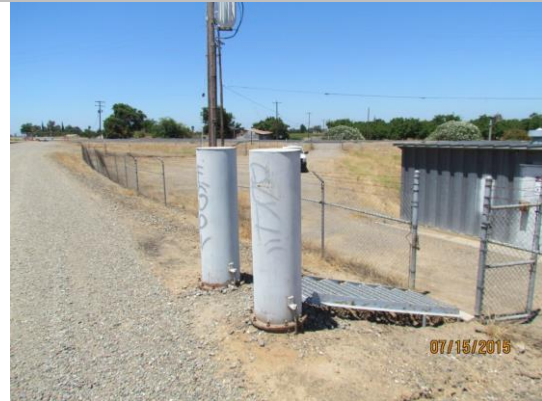
Photo 1 of 1 : ST_2015_NA0017_20_21_20150724_00027.jpg

LM Start	0.00	Rating **	A	Issue No.	21
LM End	0.00	Issue Type +	Ma	Location *	
Category	Pump Stations			GPS Latitude/Longitude	
				Start	End
Item	Security Fencing			37.973983 °	37.973983 °
				-121.229967 °	-121.229967 °
DWR ID	DWR_NA0017_20_t_2012_21				
Action/Comments					
Inspector Comments: Security fencing was undamaged and prevented unauthorized access.

View of the security fencing.
